# **INSPECTION REPORT**

File #9514 Date: January 23, 2023 Time: 2:30 PM Completion Time: 5:30 PM.

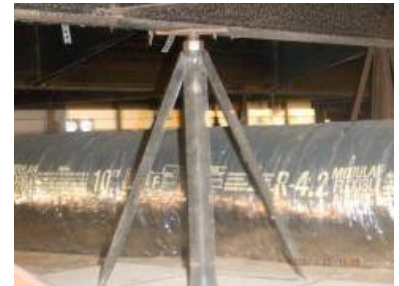
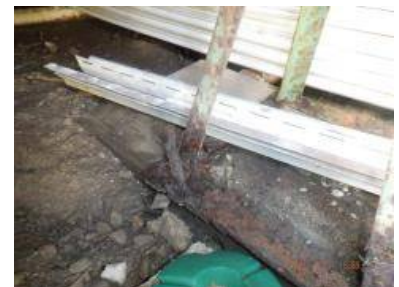
[CR] Some jack stands were rusted/deteriorated. We recommend correcting the condition(s) noted.

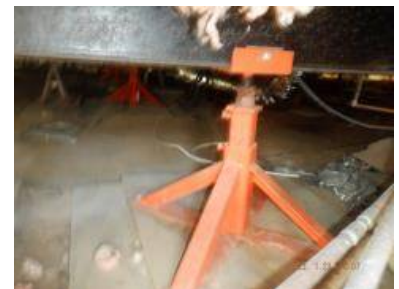
[NOTE] There were newer added jack stands present.

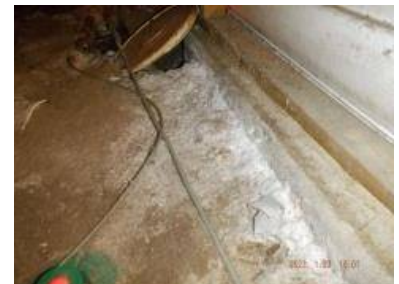
[CR] There was a condition known as efflorescence on portions of the foundation walls. This is a salt deposit left when moisture in the foundation evaporates. It indicates that the foundation is experiencing wet and dry cycles. We recommend the exterior grading and drainage be improved to divert moisture away from the foundation.

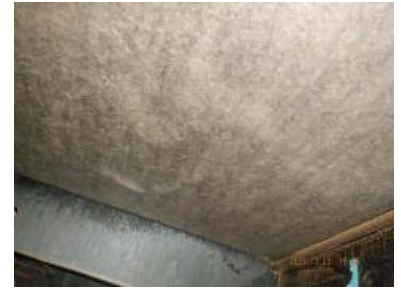
[NOTE] Most areas of the subfloor were inaccessible and not visible for inspection due to insulation. Any areas or deficiencies concealed from view due to this condition are excluded from this report. No visible signs of reportable conditions were noted in these areas.

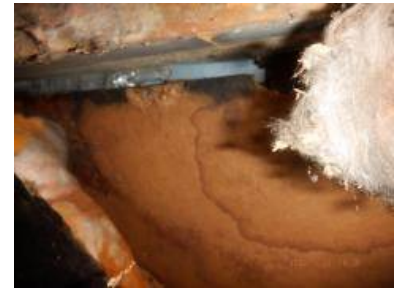
[CR] Water stains were noted in areas. The area was dry during the inspection. Monitoring the area for further staining and moisture evidence is recommended. If further moisture-related conditions are noted, corrective measures should be taken to eliminate the source of the moisture before deterioration results.

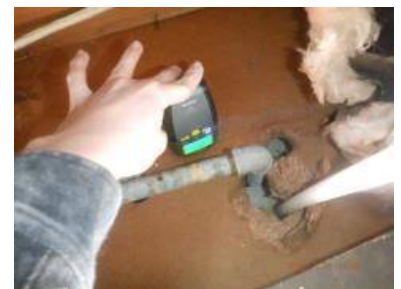
[FE] There was moisture staining and damage to the subflooring in some areas. The area tested dry at time of inspection. We recommend further evaluation and corrections by a specialist in the appropriate trade.

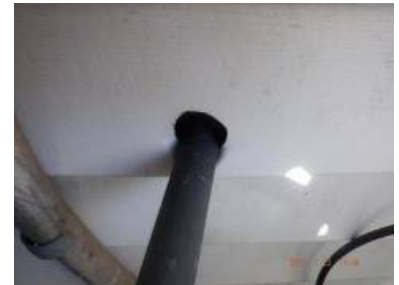
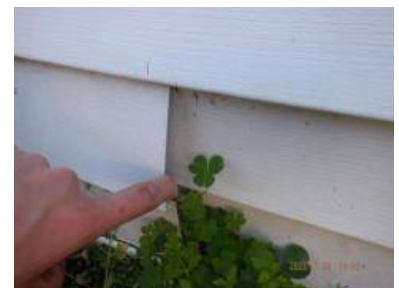
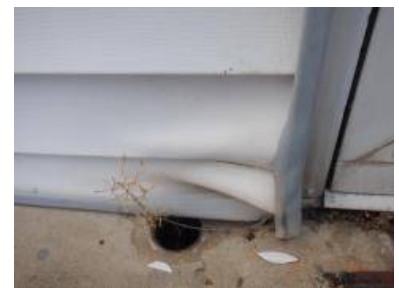
311 MFG. SIDING:	[CR] There were gaps between the manufactured siding and adjacent materials. These conditions are conducive to moisture intrusion/deterioration. We recommend correcting the condition(s) noted.
	[CR] The manufactured siding was loose/damaged at some areas of the building. These conditions are conducive to moisture intrusion/deterioration. We recommend correcting the condition(s) noted.
	[CR] The manufactured siding was damaged/deteriorated at a lower area of the building by the attached workshop. These conditions are conducive to moisture intrusion/deterioration. We recommend correcting the condition(s) noted.

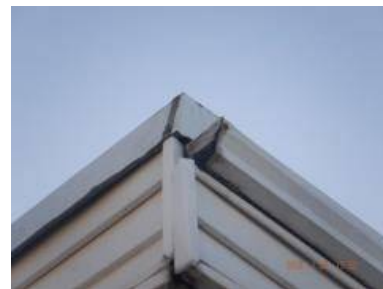
[FE] There were damaged/deteriorated trim materials noted at the trim areas. We recommend further evaluation and corrections by a specialist in the appropriate trade.

[FE] There was evidence of conditions that require further evaluation by a pest control operator. We recommend further evaluation and corrections by a specialist in the appropriate trade.

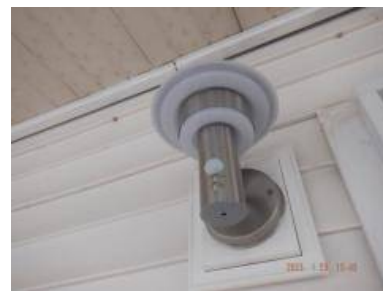
[FE] The motion detector light(s) could not be checked in the daytime. We recommend inquiring about the condition(s) noted.

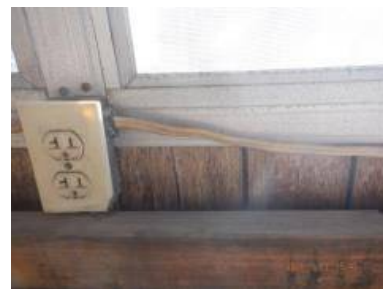
[SC] There was improper wiring installed in the form of nonmetallic sheathed wiring exposed to human contact and/or mechanical damage. We recommend correcting the condition(s) noted.

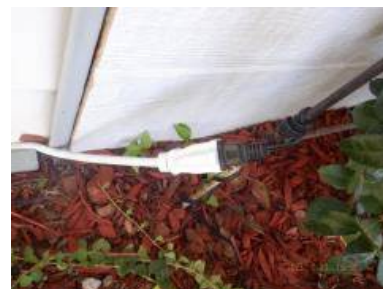
[SC] There was improper wiring installed in the form of extension cords or cord-type wiring. This type of wire is for temporary use only. We recommend correcting the condition(s) noted.

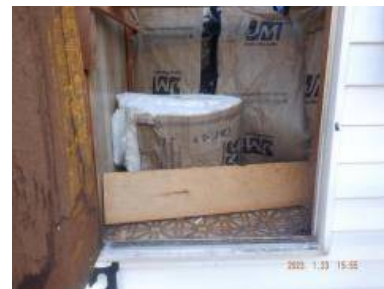
[CR] The insulation was installed in the wrong direction in the storage closet. We recommend correcting the condition(s) noted.

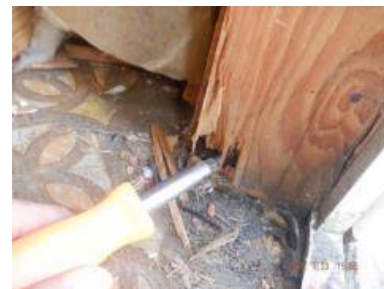
[FE] There was damaged wood on the door trim of the storage closet. We recommend further evaluation and corrections by a specialist in the appropriate trade.

[FE] There was evidence of conditions that require further evaluation by a pest control operator. We recommend further evaluation and corrections by a specialist in the appropriate trade.

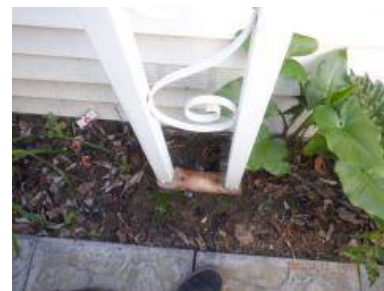
[CR] Some of the metal posts were loose from the ground. We recommend correcting the condition(s) noted.

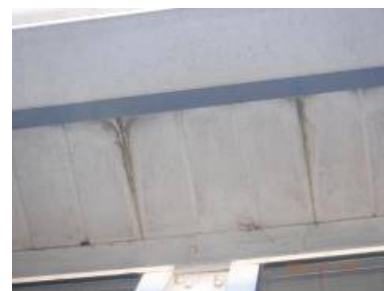
[CR] The patio enclosure showed evidence of moisture intrusion at the seams. We recommend locating and correcting the source as well as any damaged materials.

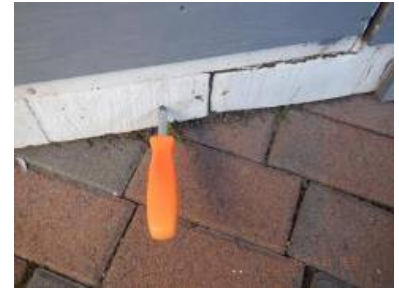
[FE] There was moisture damage to the shed. The area tested wet at time of inspection. We recommend further evaluation and corrections by a specialist in the appropriate trade.

[FE] There was evidence of conditions that require further evaluation by a pest control operator. We recommend further evaluation and corrections by a specialist in the appropriate trade.

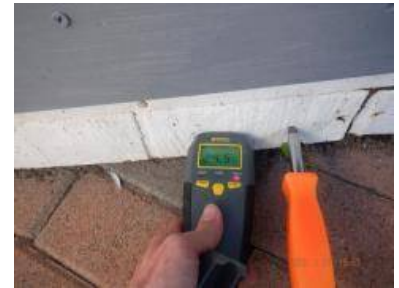
[NOTE] Testing wet.

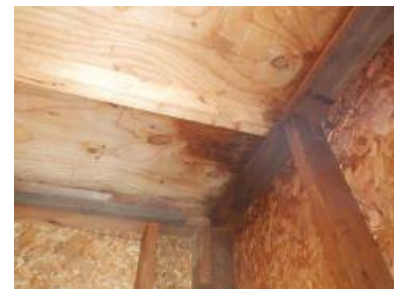
[CR] There was evidence of moisture intrusion to the shed. We recommend locating and correcting the source and any damaged materials.

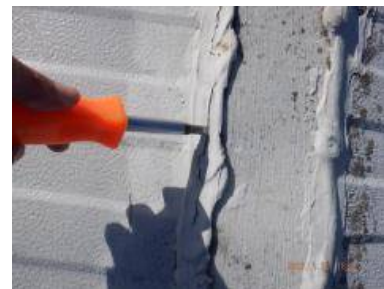
[CR] Some seams need to be re-sealed. These condition(s) are conducive to moisture intrusion and deterioration. We recommend correcting the condition(s) noted.

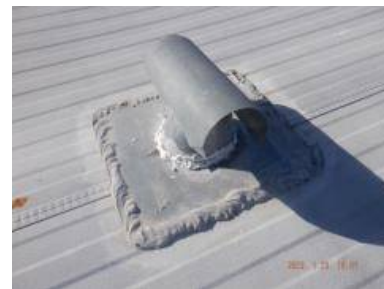
[CR] Some flashings were installed in a sub standard manner. These condition(s) are conducive to moisture intrusion and deterioration. We recommend correcting the condition(s) noted.  
[NOTE] Flashings need to be re-sealed ideally on an annual basis to prevent moisture intrusion.

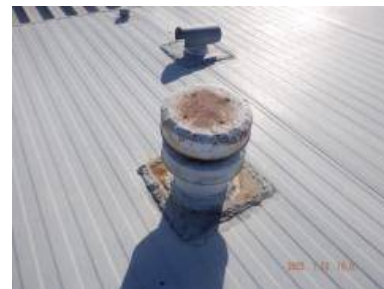
[CR] There were rusted-out/deteriorated flue pipe cap(s). We recommend correcting the condition(s) noted.

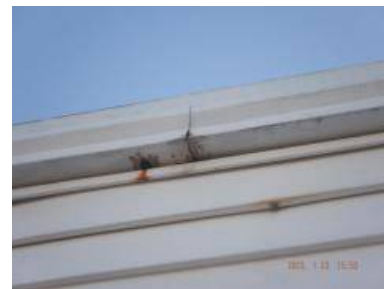
[CR] The gutters showed evidence of leakage at some seams. We recommend correcting the condition(s) noted.

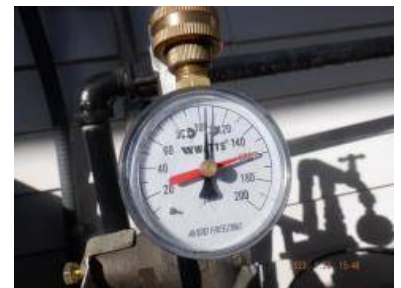
[CR] The pressure was measured at an exterior hose faucet and was 101-110 PSI, which exceeds the 80 PSI standard. This condition is conducive to plumbing leaks (pipes and faucets). We recommend installing a pressure regulator to limit the water pressure to 80 PSI per the building standards.

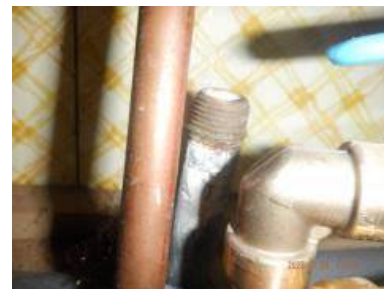
[FE] There was evidence of galvanized steel piping that appeared to be terminated. Inquire about this condition. We recommend further evaluation and corrections by a specialist in the appropriate trade.

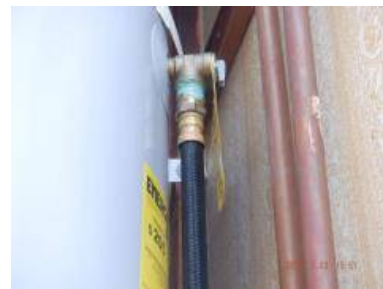
[NOTE] Material should not be flexible.

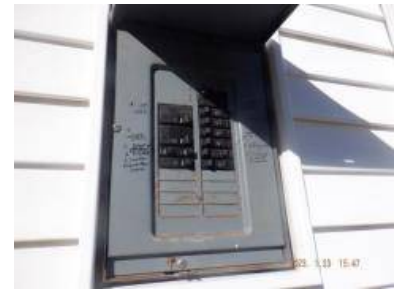
[SC] A number of breakers were not labeled clearly. We recommend they be accurately labeled to allow individual circuits to be shut off for maintenance or emergency needs. [NOTE] Labeling should be more detailed.

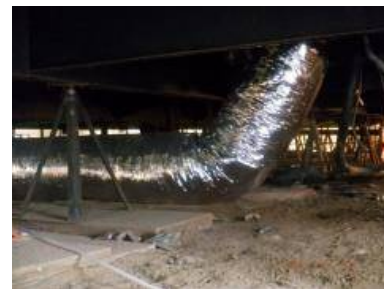
[CR] The ducting was in contact with the soil in the crawlspace. These condition(s) are conducive to moisture intrusion and deterioration. We recommend correcting the condition(s) noted.

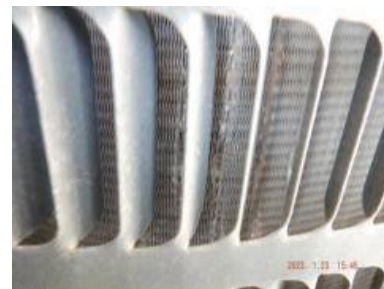
[CR] A number of the coil fins of the condensing unit were damaged/deteriorated. This condition reduces the unit's overall performance. We recommend correcting the condition(s) noted.

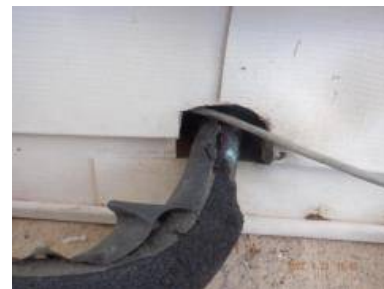
[CR] The coolant lines were not sealed to the wall where they entered the building. This condition allows for rodent access. We recommend correcting the condition(s) noted.

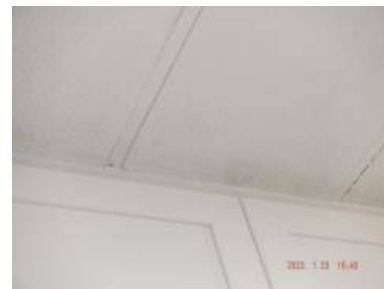
[FE] Past repairs were noted on the wall(s)/ceiling. Inquire about any previous work done.

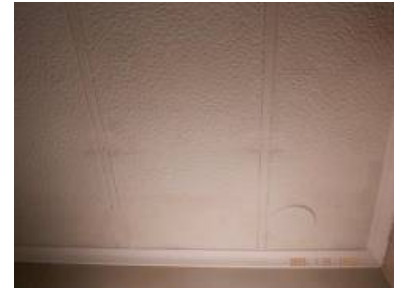
**[FE]** Past repairs were noted on the wall(s)/ceiling. We recommend inquiring about any previous work done.

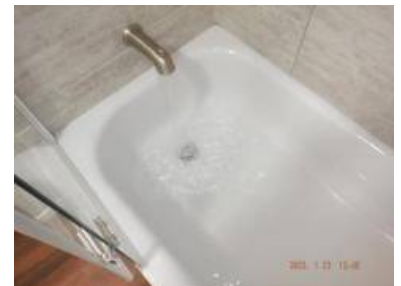
**[CR]** The tub drain was slow/blocked. We recommend correcting the condition(s) noted.

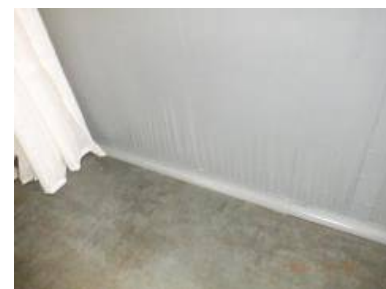
1408 WALLS/CEILING:	<p>[CR] Moisture/stains and damage were noted on the walls and ceiling in the bonus room. The area tested <u>wet</u> during the inspection. We recommend locating correcting the source as well as any damaged materials.</p>
---------------------	---

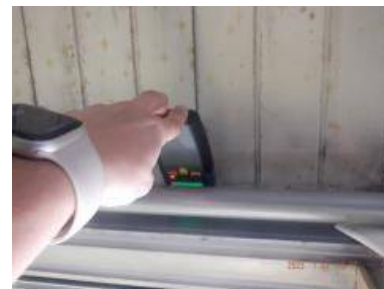
[NOTE] Testing wet.

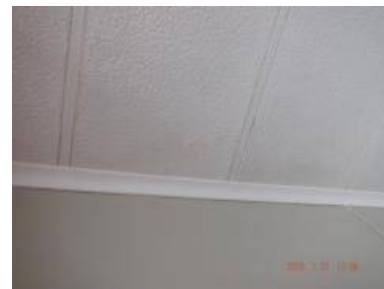
[NOTE] Living room.

[CR] Moisture/stains and damage were noted on the walls and ceiling in several areas. The area tested dry during the inspection. We recommend locating and correcting the source as well as any damaged materials.

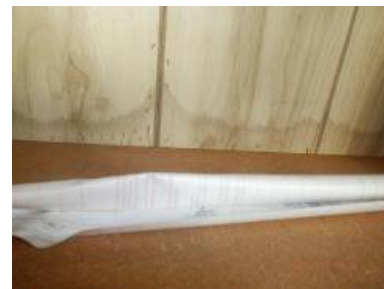
[CR] Moisture/stains were noted on the wall in the living room cabinet. The area tested dry during the inspection. We recommend locating and correcting the source as well as any damaged materials.

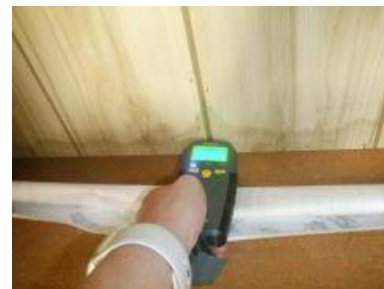
[NOTE] Testing dry.

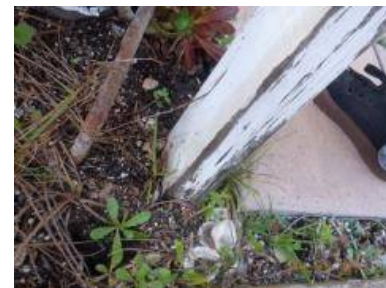
[CR] There was earth to wood contact in areas of the carport posts. These condition(s) are conducive to moisture intrusion and deterioration. We recommend correcting the condition(s) noted.
