INSPECTION REPORT

File #9513 Date: January 19, 2023 Time: 1:00 Completion Time: 3:00 INSPECTION WAS RESCHEDULED DUE TO WATER, ELECTRIC, AND GAS BEING OFF AND ROOF INCOMPLETE)

Year Built: 1965, 1,683 square Ft. 1 story single-family residence as stated by buyers agent and online listing.

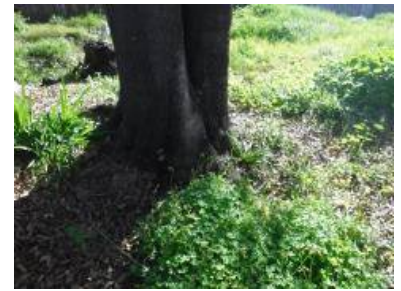
[CR] Tree(s) were planted too close to the building. We recommend considering removal, as trees continue to grow in size and damage may occur to the foundation, structure, plumbing system or roof. [NOTE] We recommend monitoring the conditions noted.

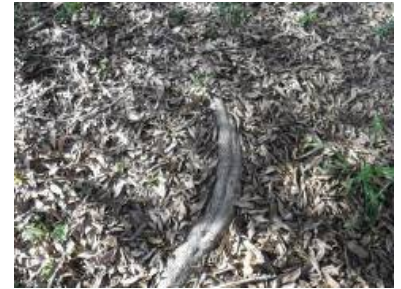
[NOTE] Roots noted near the foundation.

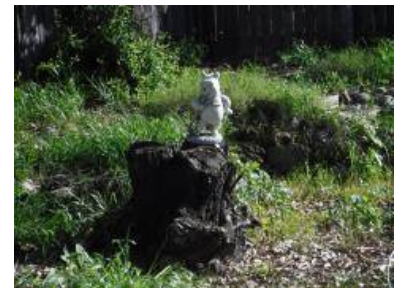
[NOTE] There were cut down trees and tree stumps present on the property. Inquire about this condition.

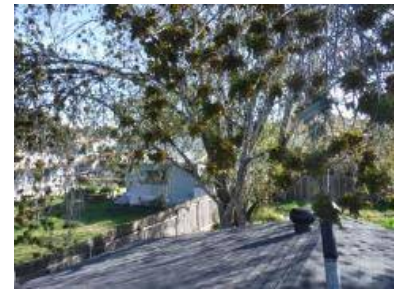
[FE] Inspector noted areas that appear to be sagging and/or bouncy. We recommend further evaluation and corrections by a specialist in the appropriate trade.

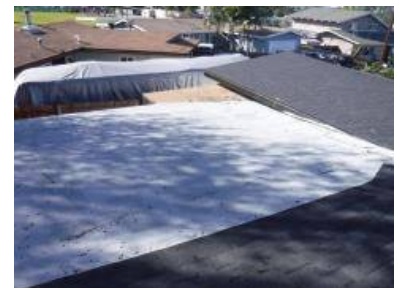
[CR] Evidence of ponding was noted. The presence of shallow ponds of water is not unusual. Regular maintenance of the areas is vital to prevent the build-up of vegetation, debris, sagging and possible damage to the roof.

[CR] Trees were touching/overhanging the roof. We recommend they be trimmed and the debris removed to prevent damage to the roof and to prevent animal access.

[CR] There was debris accumulating on the roof. We recommend the debris be removed and the roof be inspected regularly.

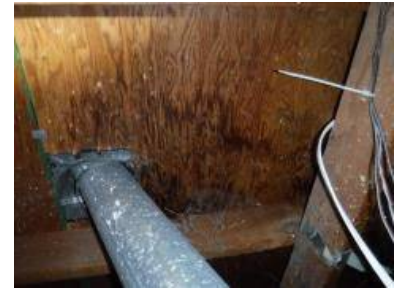
[FE] Moisture stains were noted on the sheathing and framing in areas. The stains tested to be dry during the inspection. We recommend locating and repairing the source as well as any damaged materials.

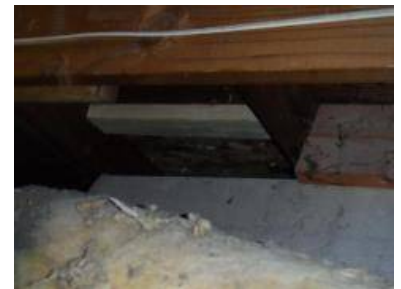
[FE] Past repairs were noted to the framing in areas. Inquire about any previous work done.

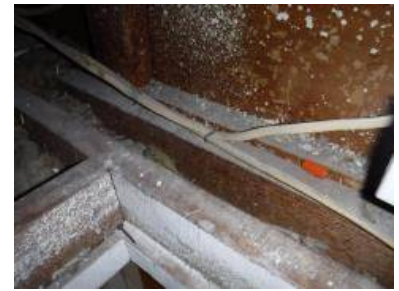
[SC] The exposed wiring within six feet of the attic access opening was not protected from damage. We recommend correcting the condition(s) noted.

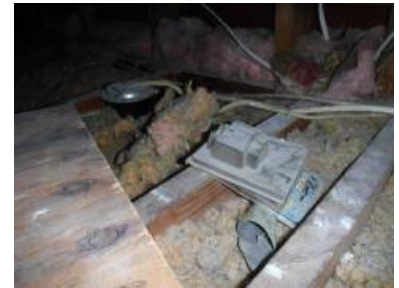
[FE] There was evidence of conditions that require further evaluation by a pest control operator. We recommend further evaluation and corrections by a specialist in the appropriate trade.

[CR] There was trash/debris present in the attic. We recommend correcting the condition(s) noted.

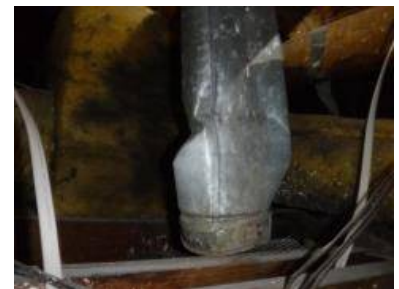
[CR] The flue was crushed and damaged. We recommend correcting the condition(s) noted.

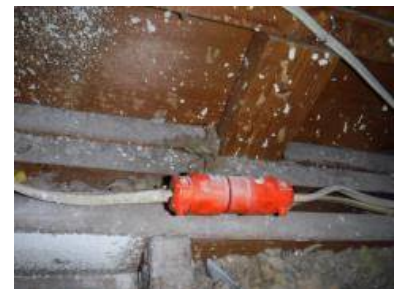
[NOTE] There was a plug connection present in the attic. Inquire about this condition.

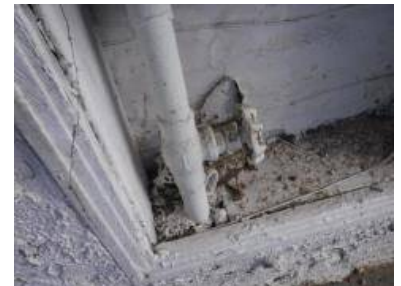
[FE] There is another shutoff valve locate at the front of the building. Inquire about this condition.

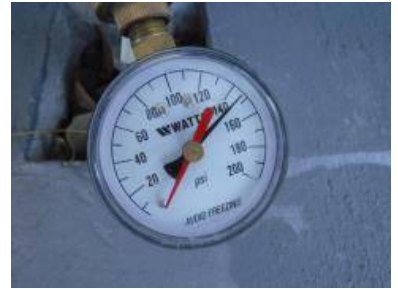
[CR] The pressure was measured at an exterior hose faucet and was 120-140 PSI, which exceeds the 80 PSI standard. This condition is conducive to plumbing leaks (pipes and faucets). We recommend installing a pressure regulator to limit the water pressure to 80 PSI per the building standards.

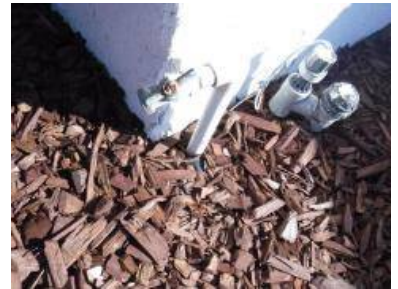
[FE] There was no water flow at some hose faucet(s). We recommend further evaluation and correction(s) by a specialist in the appropriate trade.

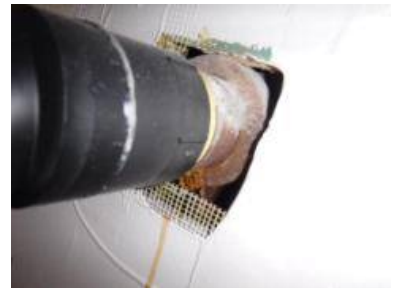
[FE] Due to the age of the building, there may be cast iron waste piping present in areas that cannot be seen. Any plumbing concealed from view is excluded from this report and not inspected. We recommend inquiring with a specialist as to the presence and/or condition of this material. We recommend further evaluation and corrections by a specialist in the appropriate trade.

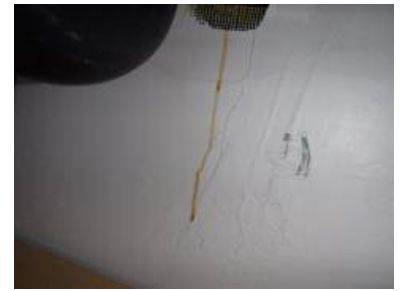
[NOTE] There was evidence of past leakage. We recommend monitoring the conditions noted and correcting as needed.

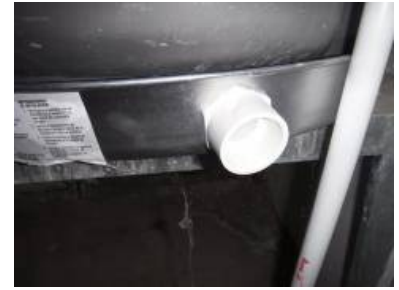
[RU] There was a drip/drain pan present but it should either be capped off or piped to the exterior.

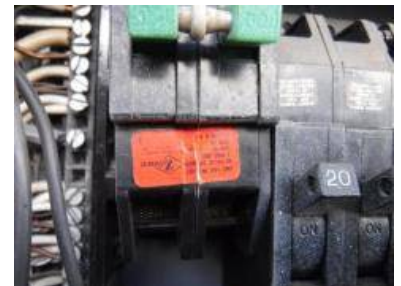
[SC] The building's main electrical service panel was manufactured by Federal Pacific / Stab-Lok / Zinsco. This panel has been known to present latent hazards by malfunctioning under certain conditions resulting in jammed circuit breakers. The breakers may not trip (disconnect) under imposed load conditions. Failure can also occur at the connections to the bus bars due to inadequate bending space for the service entrance conductors. We recommend further evaluation by a specialist in the appropriate trade.

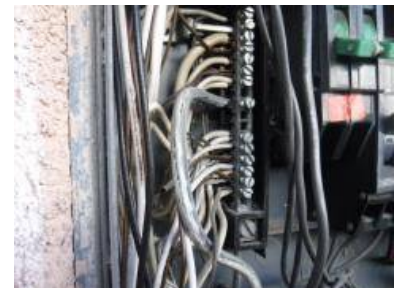
[FE] Double lugging was noted at the neutral busbar. We recommend further evaluation and corrections by a specialist in the appropriate trade.

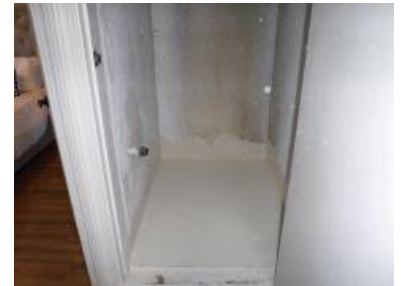
[FE] The heating system present is considered undersized for the size and square footage of the building. We recommend further evaluation and corrections by a specialist in the appropriate trade.

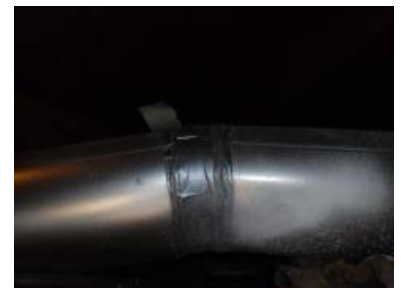
[CR] The insulation on the conditioned air ducts in the attic was damaged and/or in poor condition. We recommend correcting the condition(s) noted.

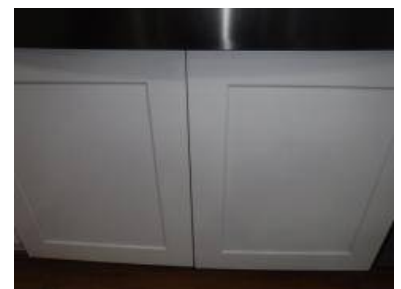
[CR] There were unfinished materials present on the counter to the right of the fridge space. We recommend correcting the condition(s) noted.

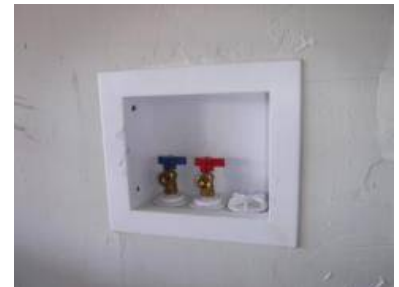
[RU] There was no visible leak pan/drain line for the washing machine in the laundry area. We recommend correcting the condition(s) noted.

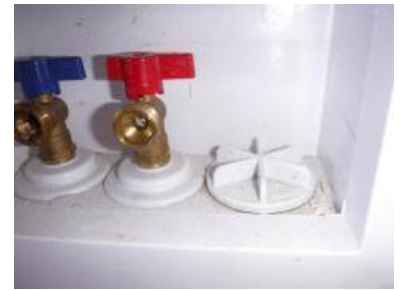
[NOTE] Drain was covered. We recommend viewing this area prior to closing.

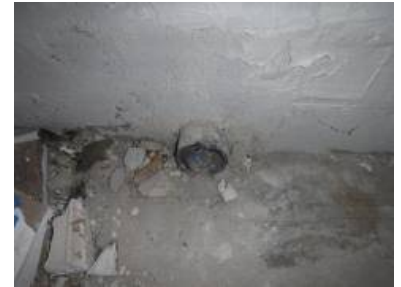
[FE] There was a vent present but the termination point was not located. Inquire about this condition.

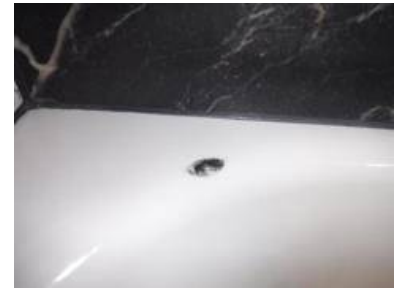
- 1319 *TUB/SHOWER:* [CR] Damage/deterioration was noted on the tub basin. We recommend correcting the condition(s) noted.

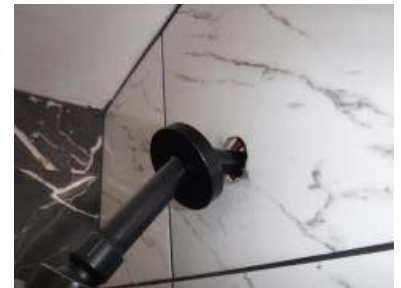
[SC] The hot and cold water were reversed at the faucet. This condition is a scald hazard. We recommend correcting the condition(s) noted.

[CR] The faucet(s)/spout were not sealed to the wall/deck. This condition is conducive to moisture intrusion into concealed spaces. We recommend correcting the condition(s) noted.

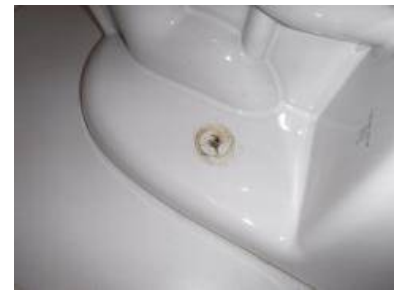
[CR] Toilet bolt covers were missing. We recommend correcting the condition(s) noted.

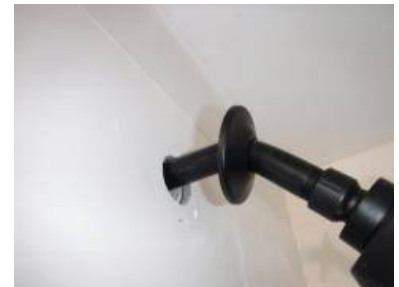
[CR] The faucet(s) were not sealed to the wall. This condition is conducive to moisture intrusion into concealed spaces. We recommend correcting the condition(s) noted.

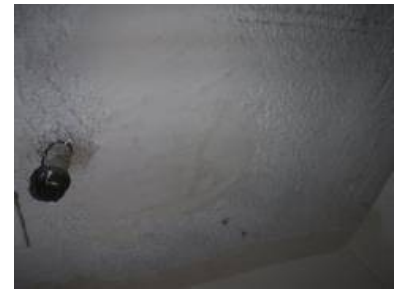
[FE] Past repairs were noted on the wall(s)/ceiling. We recommend inquiring about any previous work done.

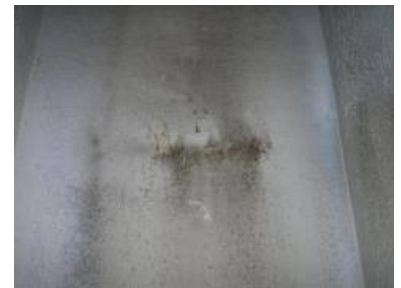
[CR] The walls in the hallway closet were discolored/dirty. We recommend correcting the condition(s) noted.

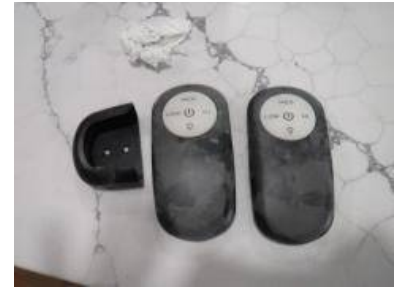
[CR] Some remotes do not have mounts. We recommend correcting the condition(s) noted.

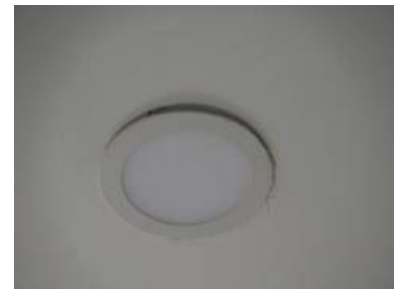
[CR] One light in the bonus room failed to function. We recommend correcting the condition(s) noted.

[CR] Some lights need to be re-sealed and mounted loose from the ceiling. We recommend correcting the condition(s) noted.

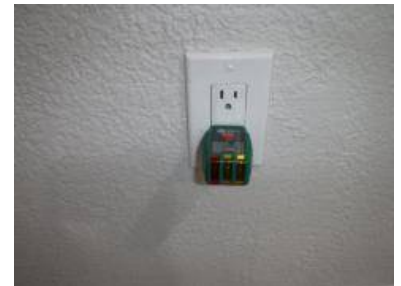
[CR] There was no power at a dining area receptacle. We recommend correcting the condition(s) noted.

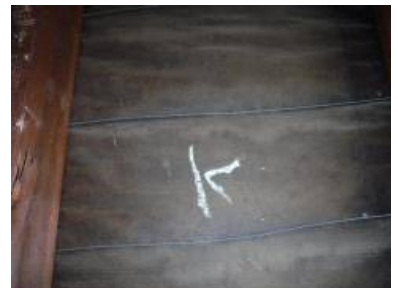
[FE] There were pest company markings present in areas. We recommend further evaluation and corrections by a specialist in the appropriate trade.

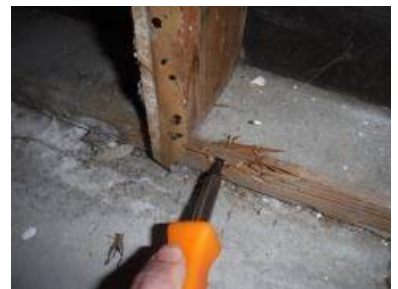
[FE] Damaged framing members were noted in several areas. We recommend further evaluation and corrections by a specialist in the appropriate trade.

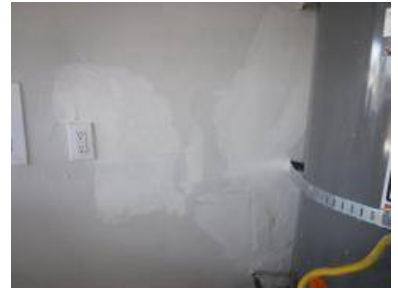
[FE] Past repairs were noted on the wall(s)/ceiling. We recommend inquiring about any previous work done.

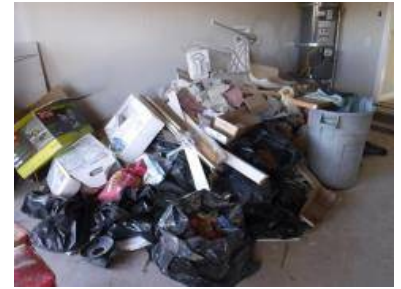
[CR] There was trash/debris present in the garage. We recommend correcting the condition(s) noted.

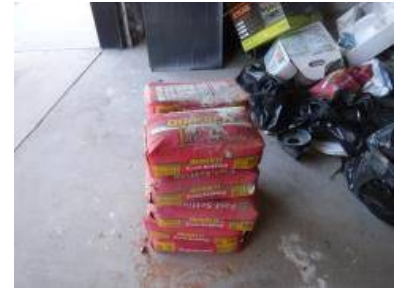
[NOTE] There were extra construction materials present.

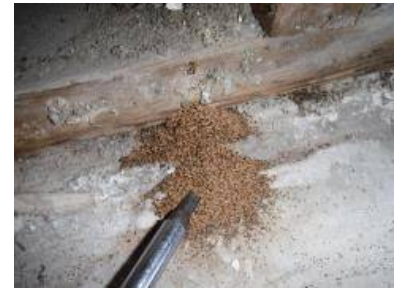
[FE] There was evidence of conditions that require further evaluation by a pest control operator. We recommend further evaluation and corrections by a specialist in the appropriate trade.
[NOTE] Droppings.
