# **INSPECTION REPORT**

File #9514 Date: January 23, 2023 Time: 2:30 PM Completion Time: 5:30 PM.

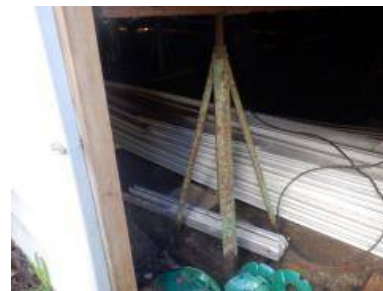
#### 201 TYPE:

Foundation types: Metal frame under the mobile home and supported by adjustable metal foundation stands.

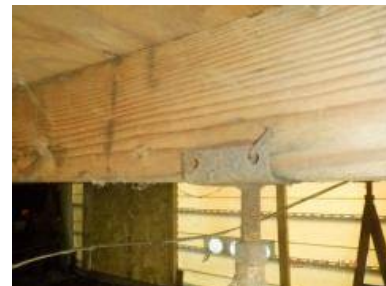
#### 202 BOLTS/BRACING:

There were a number of clamps noted that fastened the metal frame of the manufactured building to the metal foundation stands.

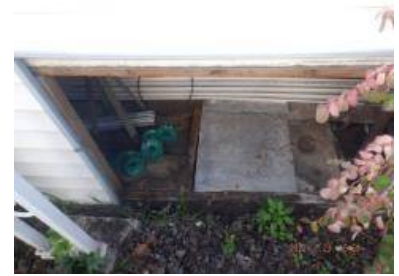
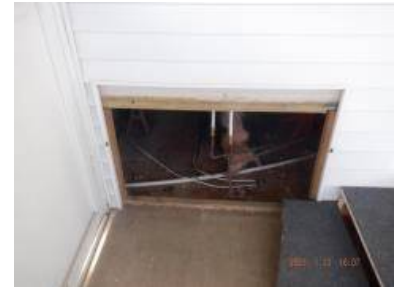
## 206 ACCESSIBILITY:

Accessed from the exterior at the right and left (2x) sides.

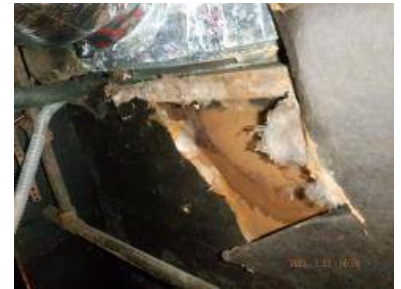
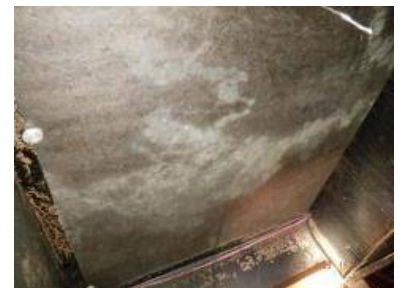
[CR] Water stains were noted in areas. The area was dry during the inspection. Monitoring the area for further staining and moisture evidence is recommended. If further moisture-related conditions are noted, corrective measures should be taken to eliminate the source of the moisture before deterioration results.

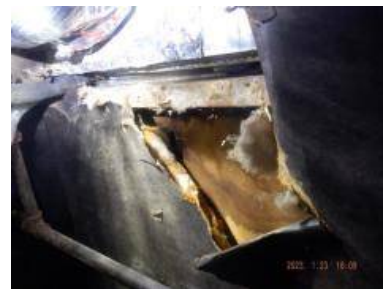
[FE] There was moisture staining and damage to the subflooring in some areas. The area tested dry at time of inspection. We recommend further evaluation and corrections by a specialist in the appropriate trade.

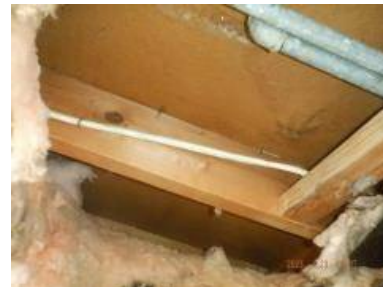
[CR] The rodent barrier was damaged/missing in areas. We recommend correcting the condition(s) noted.

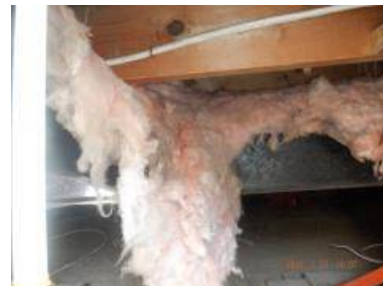
215 INSULATION:

[CR] Insulation was not securely attached to the underside of the floor. We recommend correcting the condition(s) noted.

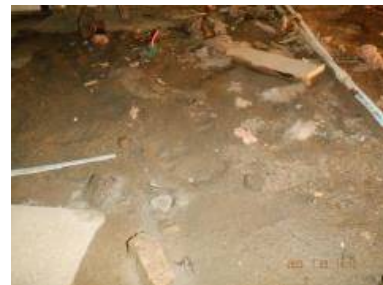
218 MOISTURE:

[CR] The crawl space was damp/wet. We recommend that all roof drainage/downspouts be directed away from the building. We recommend the ground be graded to slope away from the foundation, and the installation of surface drains and concrete walkways around the perimeter is recommended.

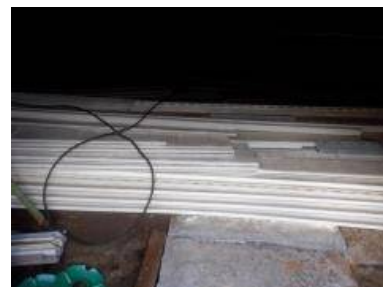
220 OBSERVATIONS:

[CR] Trash/debris were noted in the crawl space. This condition is conducive to pest/rodent infestation and/or mold growth. We recommend correcting the condition(s) noted.

[NOTE] There were construction materials present.

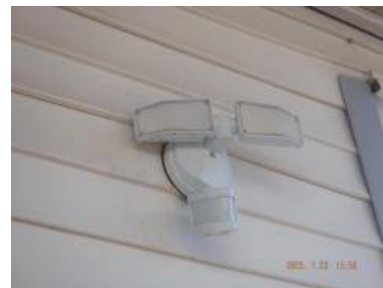
[FE] The motion detector light(s) could not be checked in the daytime. We recommend inquiring about the condition(s) noted.

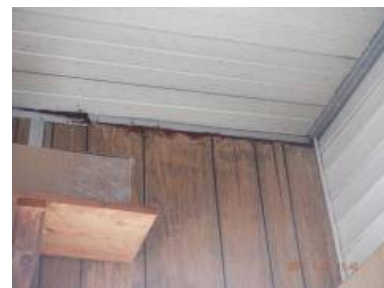
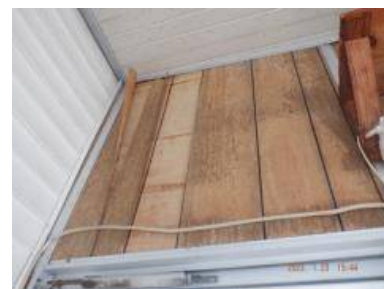
[CR] The workshop area showed evidence of moisture intrusion. We recommend locating and correcting the source and any damaged materials.

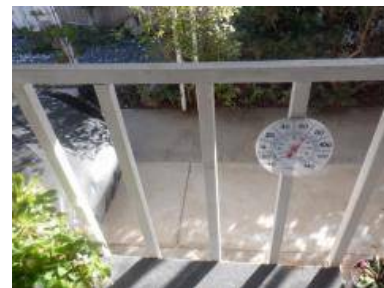
343 GUARDRAILS:

[RU] The guardrail(s) installed were in serviceable condition and appear to have meet the standards at the time of construction, however the wide spaces between the balusters pose a hazard for small children. Modern construction requires a maximum of 4 inch openings. While upgrading is not required, additional measures for child safety like netting or some other means is strongly recommended.

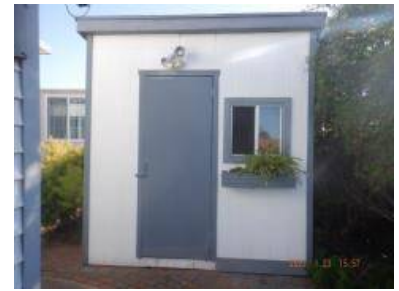
355 SHED:

[FE] These structure(s) are outside the scope of the inspection and are not inspected. We recommend consulting with a specialist regarding the operation and maintenance of this system.  
[NOTE] We recommend the system(s) be demonstrated/explained to the buyer(s).

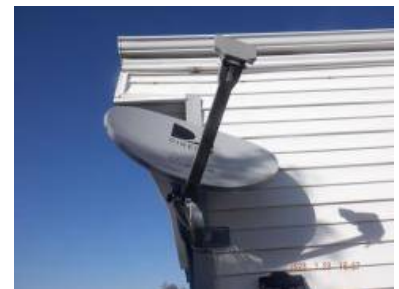
357 COMMENTS:

[FE] There was dish equipment present/fastened to the structure. Inquire about this equipment.

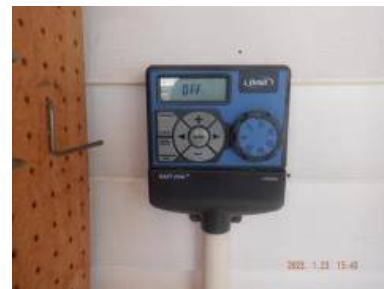
## 360 LAWN SPRINKLRS:

[FE] These system(s) are outside the scope of the inspection and are not inspected. We recommend consulting with a specialist regarding the operation and maintenance of this system. [NOTE] We recommend the system(s) be demonstrated/explained to the buyer(s).

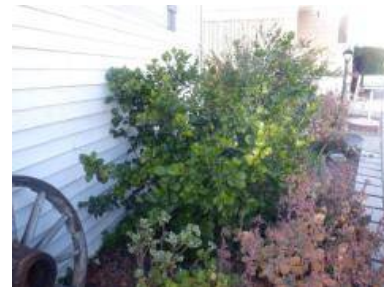
[CR] There was vegetation was growing in contact with the building. This condition limits the inspection, and is conducive to moisture intrusion/deterioration. We recommend correcting the condition(s) noted.

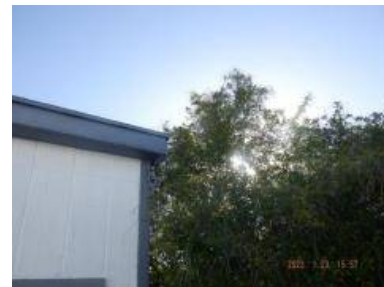
[CR] Trees were touching or overhanging the roof. We recommend they be trimmed to prevent damage to the roofing surface, and allow free flow of roof runoff.

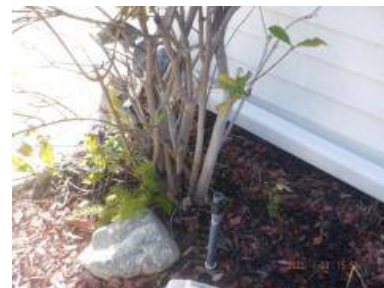
[CR] Tree(s) were planted too close to the building. We recommend considering removal, as trees continue to grow in size and damage may occur to the foundation, structure, plumbing system or roof. [NOTE] We recommend monitoring the conditions noted.

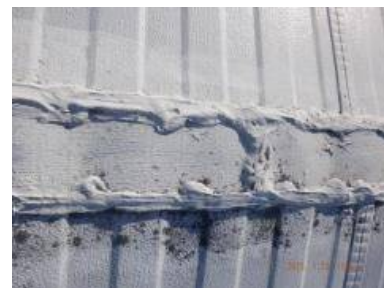
[NOTE] Some seams were serviceable.

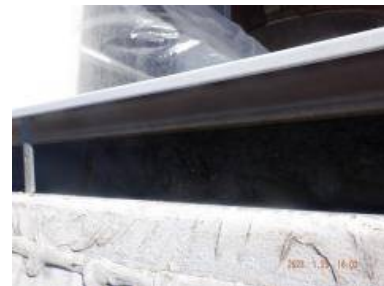
[CR] The rain gutter(s) were improperly sloped and holding water. We recommend correcting the condition(s) noted.

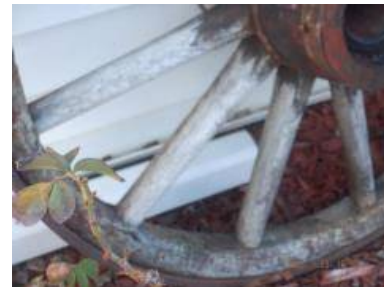
#### 421 DOWNSPOUTS:

[CR] Runoff water from the roof discharged next to the building. We recommend the downspouts be routed sufficiently away from the building to prevent ponding, pooling, and saturation of the soil at the foundation.

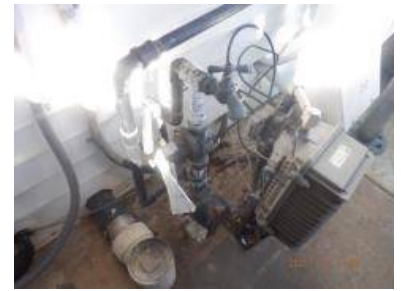
## 602 WATER SHUTOFF:

The main water shutoff valve was located at the left side of the building.

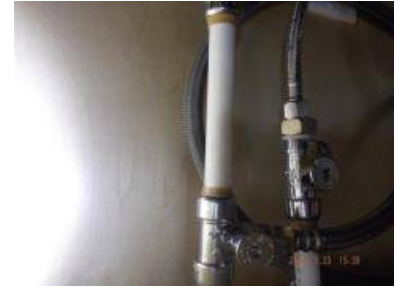
Materials: copper piping and cross-linked polyethylene pipe (PEX) where visible.

[NOTE] cross-linked polyethylene pipe (PEX)

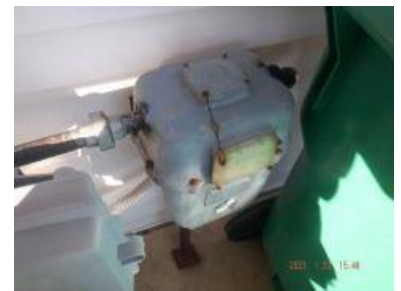
## 606 GAS SHUTOFF:

The gas meter and shutoff valve are located at the left side of the building.

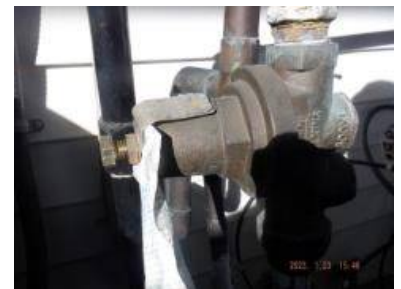
[NOTE] Water pressure regulators need periodic maintenance/replacement.

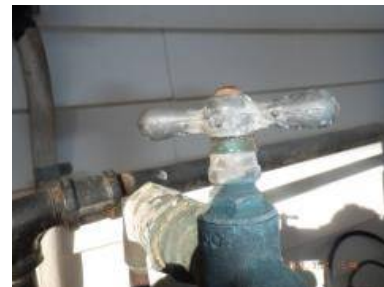
[CR] Some hose faucets leaked at the handles when operated. We recommend correcting the condition(s) noted.

[RU] There were no vacuum breakers on the exterior hose faucets. We recommend installing these devices as an upgrade.

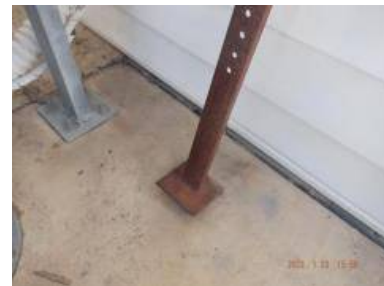
[CR] The gas meter was mounted loose to the ground. We recommend correcting the condition(s) noted.

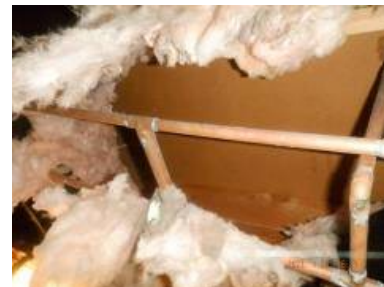
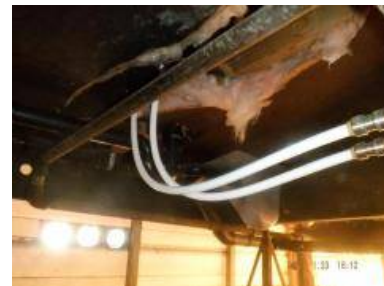
619 COMMENTS:

[FE] There was evidence of significant plumbing work done. We strongly recommend inquiring about any previous moisture issues, work done and retrieve any information on warranties + cost.

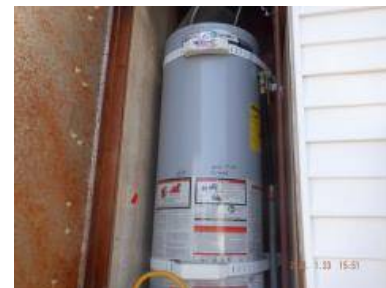
701 LOCATION:

The water heater was located in an exterior closet on the left side of the building.

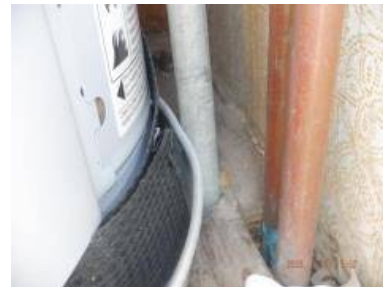
[CR] The T&P line discharges into the crawlspace. These condition(s) are conducive to moisture intrusion and deterioration. We recommend correcting the condition(s) noted.

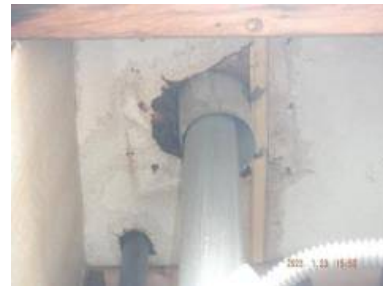
[CR] There was moisture staining and damage visible in the water heater cabinet. The area tested dry at time of inspection. We recommend locating and correcting the source and any damaged materials.

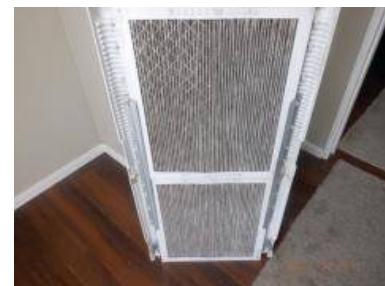
915 BLOWER / FILTER: The blower appeared serviceable  
[CR] The filter was dirty which blocks the air flow.  
We recommend the filter be cleaned or replaced.

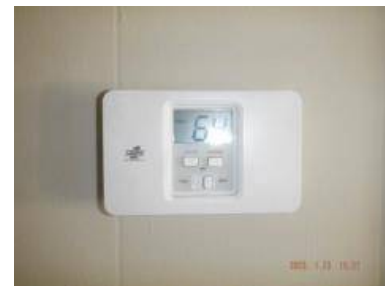
917 THERMOSTAT: [FE] The thermostat was operated and the systems failed to respond to normal operating controls. We recommend the system(s) be demonstrated/explained to the buyer(s).

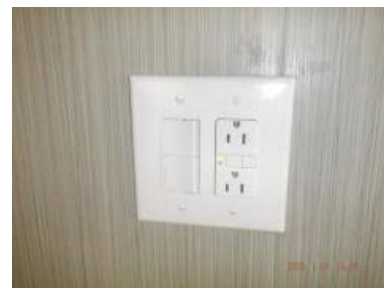
[CR] The GFCI type receptacle should be a standard 110 type. The protection would still be present. We recommend correcting the condition(s) noted.

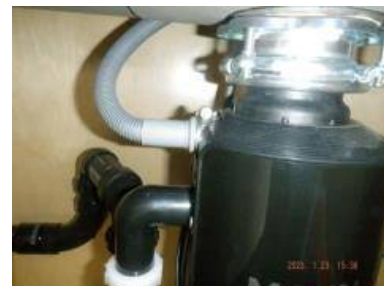
[SC] The dishwasher was connected directly to the garbage disposal which is conducive to clogging. The dishwasher should connect to an air gap device and from there to the disposal or drain piping. We recommend correcting the condition(s) noted.

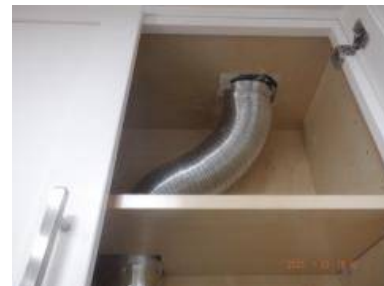
[SC] The visible portion of the exhaust vent ducting was a corrugated flexible material. This material is not approved for kitchen exhaust vents, the corrugations trap grease. We recommend correcting the condition(s) noted.

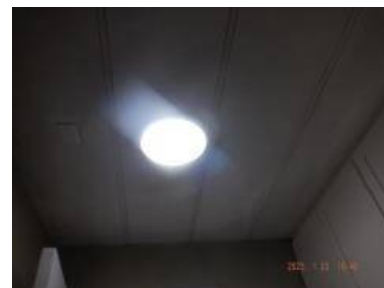
[FE] Past repairs were noted on the wall(s)/ceiling. We recommend inquiring about any previous work done.

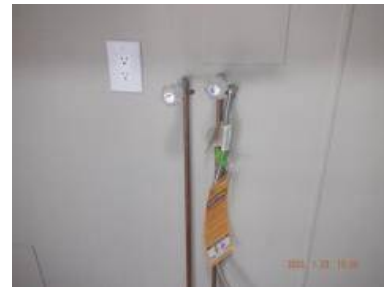
[RU] There was no visible leak pan/drain line for the washing machine in the laundry area. We recommend correcting the condition(s) noted.

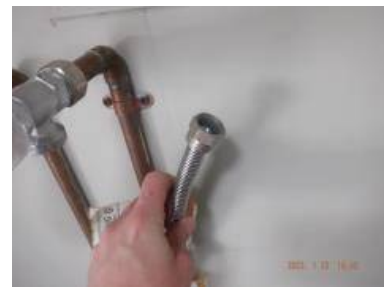
[SC] The gas line should be capped off when not in use. We recommend correcting the condition(s) noted.

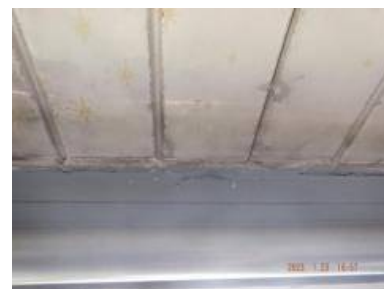
1408 WALLS/CEILING:	<p>[CR] Moisture/stains and damage were noted on the walls and ceiling in the bonus room. The area tested <u>wet</u> during the inspection. We recommend locating correcting the source as well as any damaged materials.</p>
---------------------	---

[NOTE] Additional image.

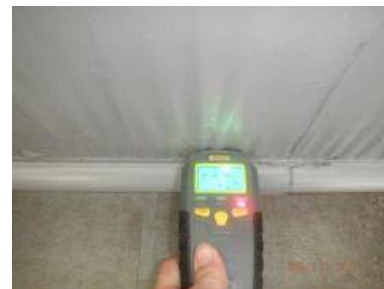
[NOTE] Testing wet.

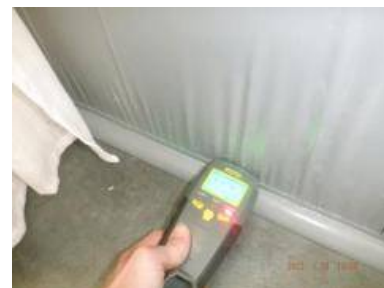
[NOTE] Testing wet.

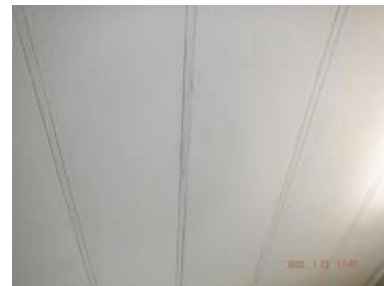
[NOTE] Guest bedroom (1)

[CR] Moisture/stains and damage were noted on the walls and ceiling in several areas. The area tested dry during the inspection. We recommend locating and correcting the source as well as any damaged materials.

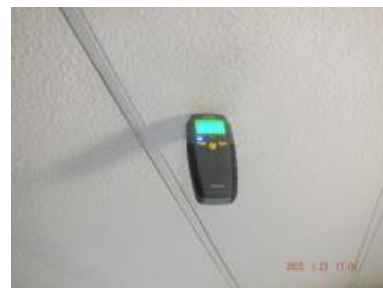
[NOTE] Testing dry with a contact moisture meter.

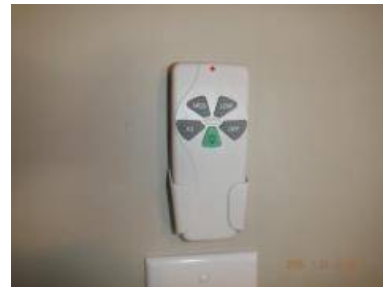
[FE] We recommend the battery operated remote system(s) be demonstrated/explained to the buyer(s).

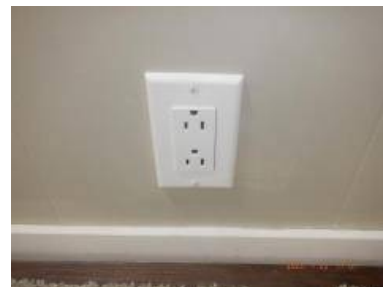
[NOTE] Hallway receptacle is GFCI protected and resets at the hallway bathroom.

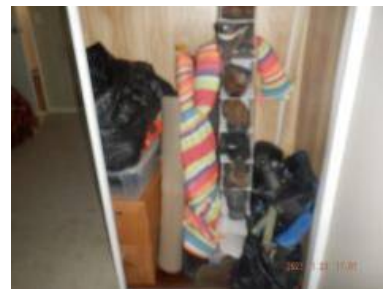
[NOTE] The visible areas of the closet(s) appeared serviceable, stored items were present. Any conditions concealed from view due to stored items is excluded from this report. We strongly recommend viewing these areas prior to closing.

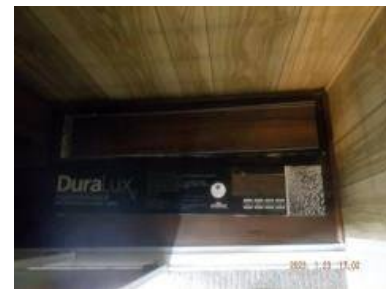
[NOTE] There was extra flooring materials present.
