INSPECTION REPORT

File #9513 Date: January 19, 2023 Time: 1:00 Completion Time: 3:00 INSPECTION WAS RESCHEDULED DUE TO WATER, ELECTRIC, AND GAS BEING OFF AND ROOF INCOMPLETE)

Year Built: 1965, 1,683 square Ft. 1 story single-family residence as stated by buyers agent and online listing.

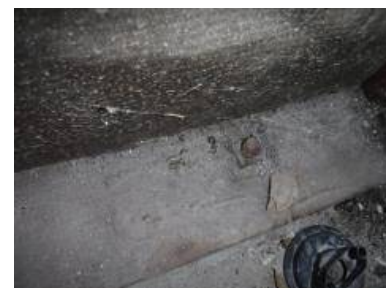
Foundation anchor bolting was visible at the unfinished walls in the garage.

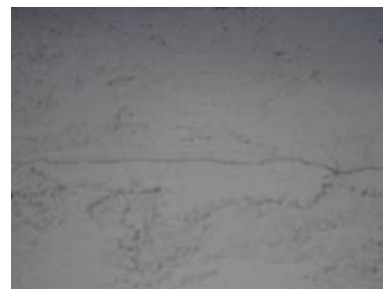
308 CONCRETE/STUCCO SIDING:	[CR] There were cracks/gaps in the stucco siding. These conditions are conducive to moisture intrusion/deterioration. We recommend correcting the conditions noted.
-----------------------------	---

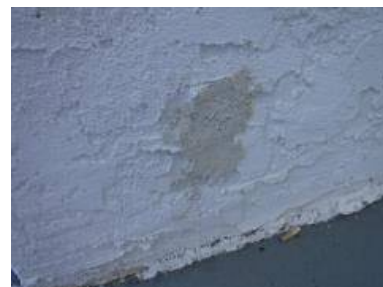
[FE] There was evidence of past repairs performed. We recommend inquiring about any previous work done.

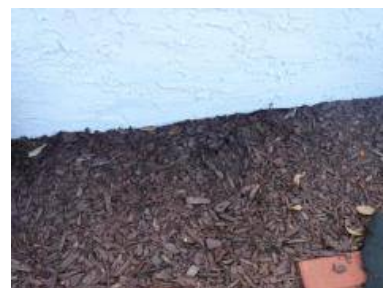
[RU] This building was built in an era before weep screeds were installed at the bottom edge of the stucco siding, the stucco was extended into the soil. The stucco wicks water up out of the soil which causes it to deteriorate from being moist for prolonged periods. We recommend minimizing moisture around the building to help protect the stucco and the foundation from moisture damage.

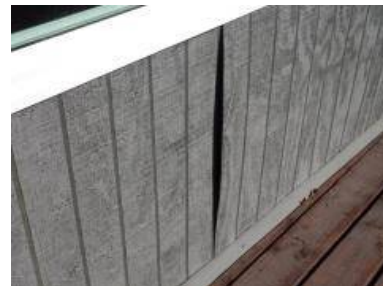
[CR] There were cracks/gaps in the manufactured wood siding. These conditions are conducive to moisture intrusion/deterioration. We recommend correcting the conditions noted.

[CR] The manufactured siding was loose/damaged at some areas of the building. These conditions are conducive to moisture intrusion/deterioration. We recommend correcting the condition(s) noted.

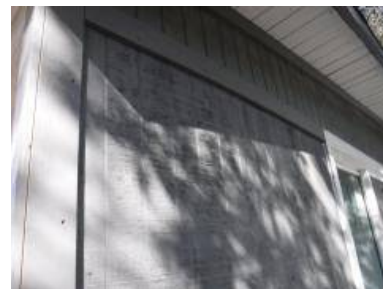
[CR] The manufactured siding finish appeared worn/weathered/aging. We recommend correcting the condition(s) noted.

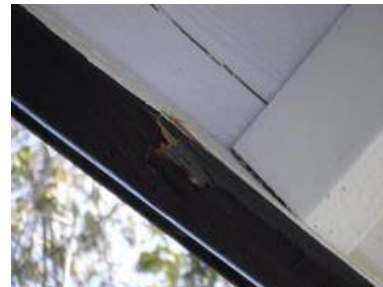
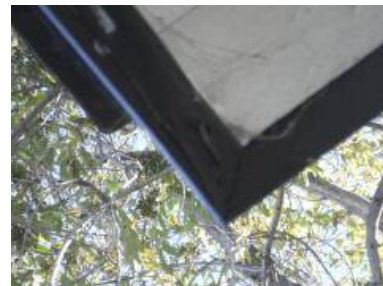
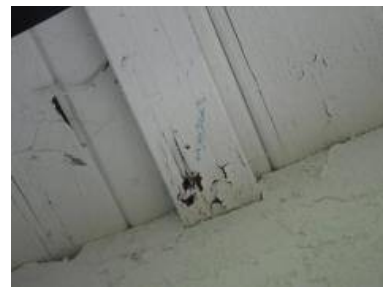
[FE] There were damaged/deteriorated trim materials noted at the eave, fascia, trim and rafter tail areas. We recommend further evaluation and corrections by a specialist in the appropriate trade.

[FE] There was evidence of conditions that require further evaluation by a pest control operator. We recommend further evaluation and corrections by a specialist in the appropriate trade.

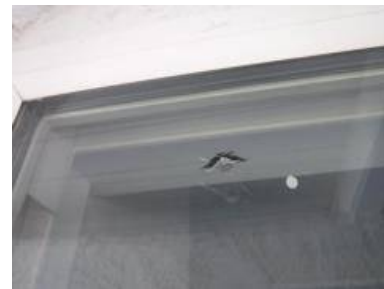
[CR] There was cracked/broken glass in a front window(s). We recommend correcting the condition(s) noted.

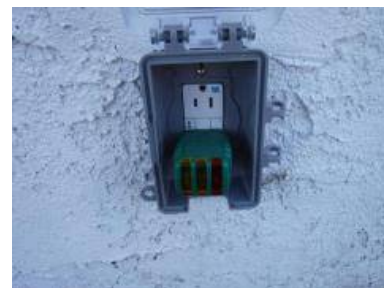
[CR] There was no power at the front GFCI receptacle and it would not reset. We recommend correcting the condition(s) noted.

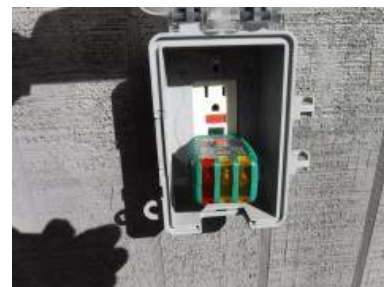
[SC] The GFCI receptacle at the right side of the building was providing power, but failed to trip when tested. This condition is safety hazard. We recommend correcting the condition(s) noted.

[CR] One right side receptacle was mounted loose from the wall. We recommend correcting the condition(s) noted.

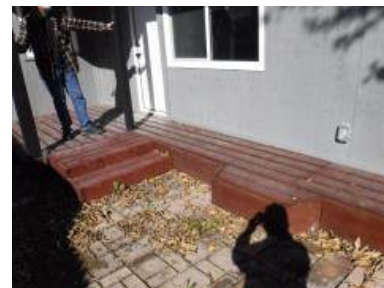
[NOTE] The wood deck appeared serviceable with signs of aging and wear.

[NOTE] The underside of the deck and framing was not accessible or visible to examine.

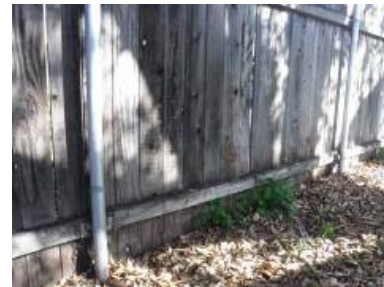
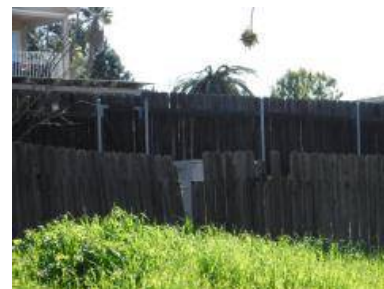
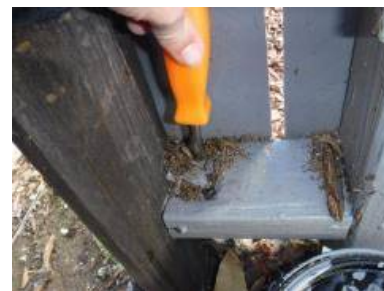
[CR] There was earth to wood contact in areas of the wood fencing. These condition(s) are conducive to moisture intrusion and deterioration. We recommend correcting the condition(s) noted.

[CR] The gate(s) needed adjustment or repairs to restore proper closing and latching operation. We recommend correcting the condition(s) noted.

[FE] There was evidence of conditions that require further evaluation by a pest control operator. We recommend further evaluation and corrections by a specialist in the appropriate trade.

[CR] The wood fencing and gates had damaged/missing fence boards. We recommend correcting the condition(s) noted.

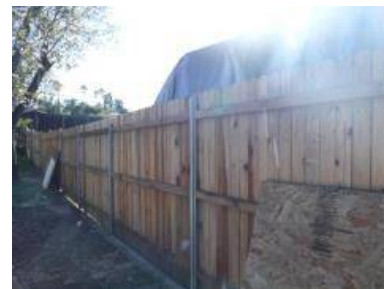
[RU] Some areas of the fencing were unpainted. This is conducive to weathering. We recommend correcting the condition(s) noted.

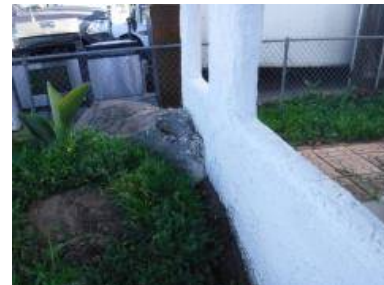
[FE] There was evidence of conditions that require further evaluation by a pest control operator. We recommend further evaluation and corrections by a specialist in the appropriate trade.

[NOTE] An area of the building was built around a boulder. Inquire about this condition.

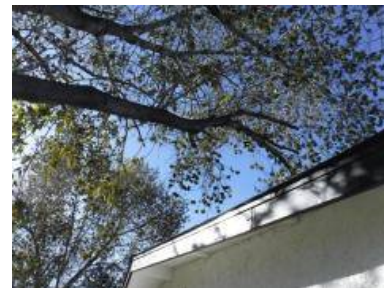
[CR] Trees were touching or overhanging the roof. We recommend they be trimmed to prevent damage to the roofing surface, and allow free flow of roof runoff.

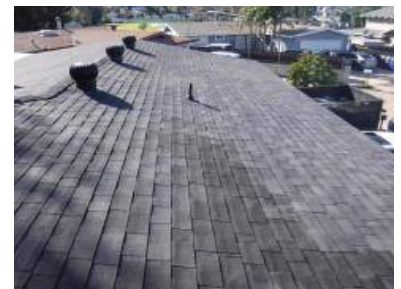
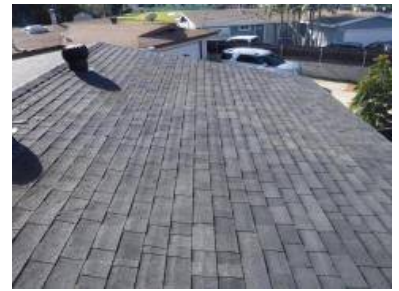
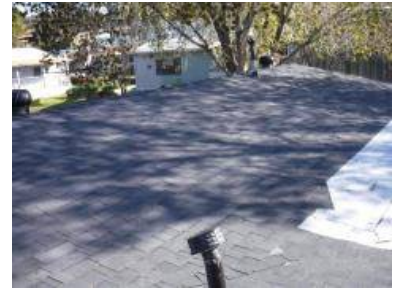
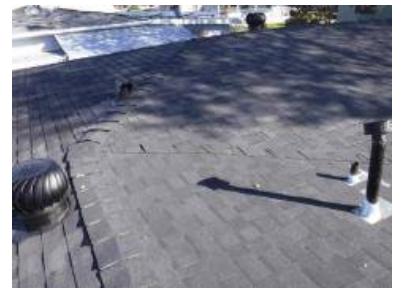
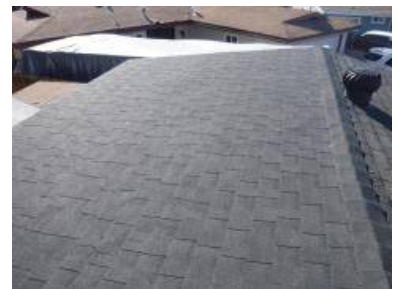
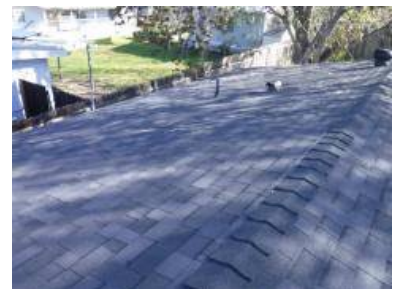
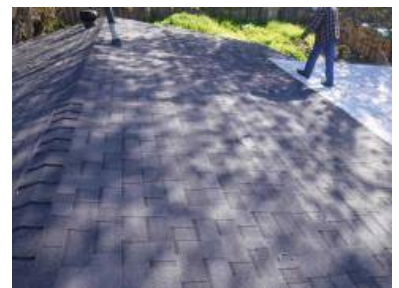
407 *COMP SHINGLE:* The visible areas of the roof appeared serviceable with signs of weathering and aging. Periodic inspection and maintenance is recommended.

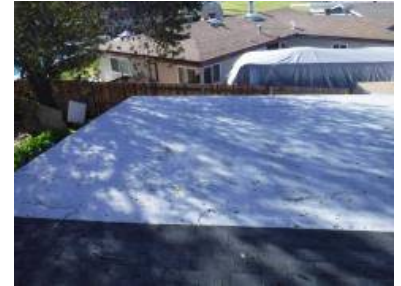
Low slope: The visible areas of the roof appeared serviceable with signs of weathering and aging. Periodic inspection and maintenance is recommended.

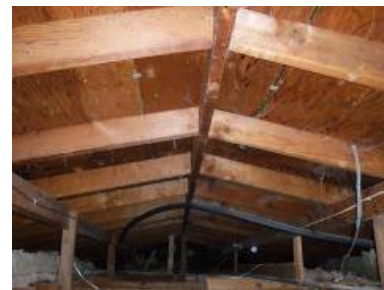
507 FRAMING: [NOTE] The original framing was noted to be in serviceable condition. Although the framing does not conform to present standards, no adverse conditions were noted and no action is necessary unless otherwise specified in this report.

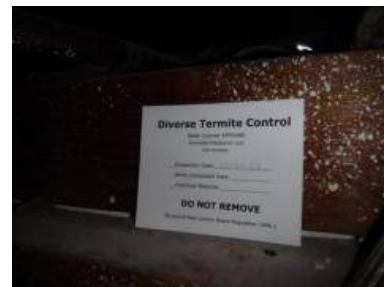
[NOTE] Tag.

[FE] Pest company markings and tags were noted in areas of the framing. We recommend further evaluation and corrections by a specialist in the appropriate trade.

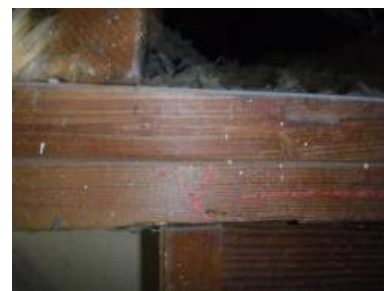
[NOTE] Pest company markings.

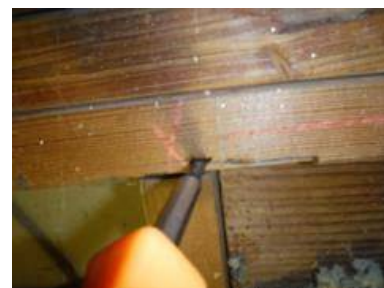
[FE] There was evidence of damaged wood framing in the attic. We recommend further evaluation and corrections by a specialist in the appropriate trade.

[FE] There was evidence of conditions that require further evaluation by a pest control operator. We recommend further evaluation and corrections by a specialist in the appropriate trade.

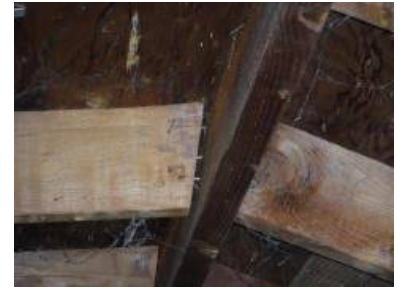
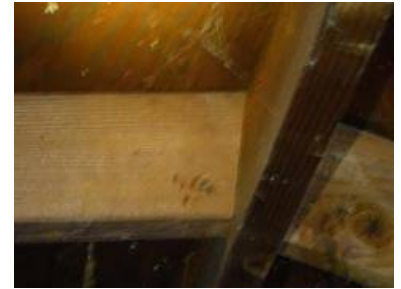
[FE] The upper ends of the rafter(s) have separated slightly from the ridge board. This condition may be from movement/settlement/seismic activity. We recommend further evaluation and correction(s) by a specialist in the appropriate trade.

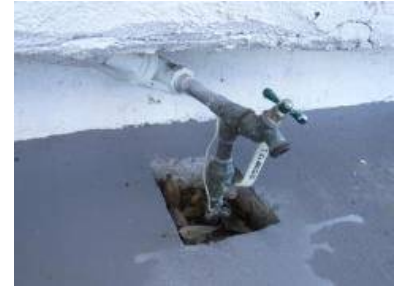
The main water shutoff valve was located at the front of the building.

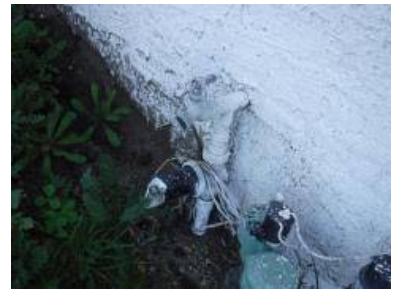
[NOTE] Additional image.

[CR] The shutoff valve is partially obstructed by the piping. We recommend correcting the condition(s) noted.

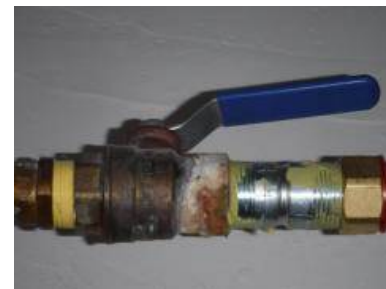
[RU] The shutoff valve and visible water supply connectors appeared serviceable, but they were not insulated. We recommend insulating the exposed water piping to minimize heat loss.

[NOTE] The water supply connectors were corroded, no leakage noted. We recommend monitoring the condition(s) noted.

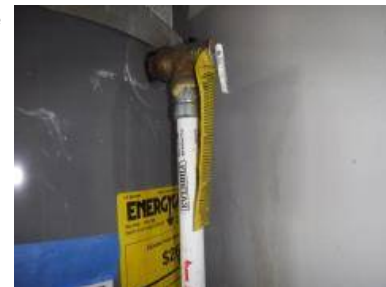
[RU] A temperature and pressure (T&P) relief valve and discharge line were installed as required. The discharge line did not extend to the exterior. We recommend it be extended to the exterior and terminated close to the ground facing downward.

[NOTE] Material was a rated plastic.

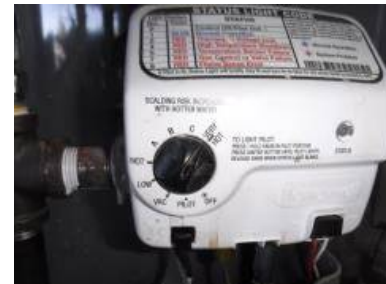
[SC] The temperature control was set to the "high/very hot" position. Excessively high water temperatures can be dangerous and inefficient. We recommend the temperature setting be lowered to the manufacturer's recommended setting.

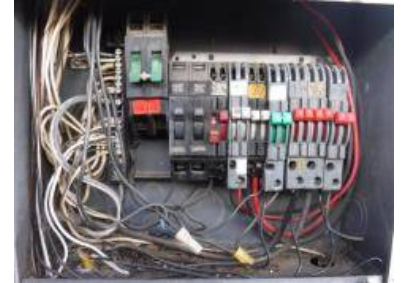
[SC] The protective "dead front" cover was missing from the panel. We recommend correcting the condition(s) noted.

[SC] The circuit breakers/fuses were not labeled. We recommend they be accurately labeled to allow individual circuits to be shut off for maintenance or emergency needs.

[FE] Breaker(s) in the main panel were in the "Off or Tripped" position. Resetting breakers is outside the scope of the inspection. We recommend further evaluation and correction(s) by a specialist in the appropriate trade.

[SC] The building's main electrical service panel was manufactured by Federal Pacific / Stab-Lok / Zinsco. This panel has been known to present latent hazards by malfunctioning under certain conditions resulting in jammed circuit breakers. The breakers may not trip (disconnect) under imposed load conditions. Failure can also occur at the connections to the bus bars due to inadequate bending space for the service entrance conductors. We recommend further evaluation by a specialist in the appropriate trade.

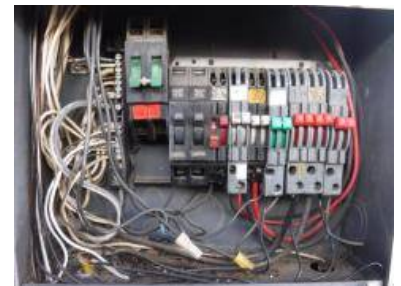
[FE] Double lugging was noted at the neutral busbar. We recommend further evaluation and corrections by a specialist in the appropriate trade.

[NOTE] The wiring within the panel appeared serviceable excluding the double lugging.

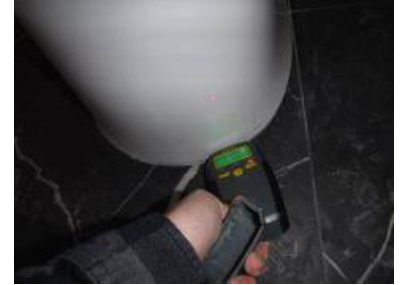
- ventilation are provided by other means.
- 1310 *HEAT & COOL:* There was no source of heat in this area and it is not required (vents present but no furnace).
- 1311 *LIGHTS/FIXTURES:* The light(s) were serviceable.
- 1312 *RECEPTACLES:* The accessible receptacles were serviceable and GFCI protected where required.
- 1313 *VENTILATION:* The exhaust vent fan functioned.
- 1314 *CABINETS/TOPS:* The cabinet(s)/ counter(s) were serviceable.
- 1315 *SINK/PLUMBING:* [CR] There was no cold water flow from the faucet. We recommend correcting the condition(s) noted.
- 1316 *TOILETS:* [CR] The toilet showed evidence of seepage/leakage at the baseline/wax ring. These condition(s) are conducive to moisture intrusion and deterioration. We recommend correcting the condition(s) noted along with any and all damaged materials.

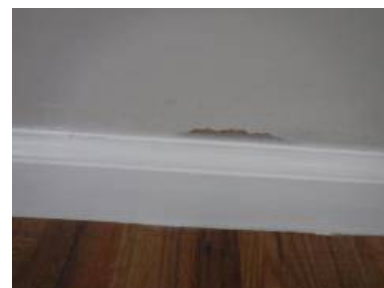
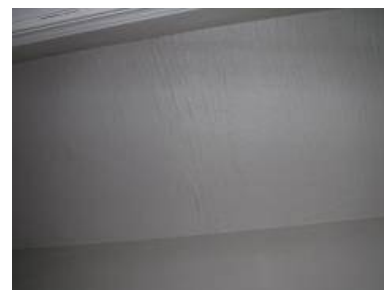
1408 WALLS/CEILING: [CR] Minor cosmetic deficiencies were noted throughout the building. We recommend correcting the condition(s) noted.

[CR] There was bubbled paint noted in some closets. We recommend correcting the condition(s) noted.

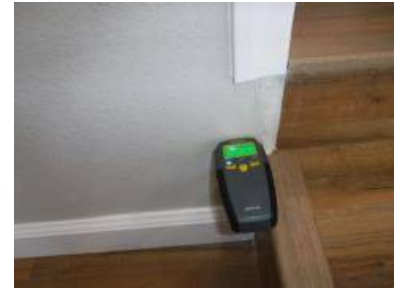
[NOTE] Additional image testing dry.

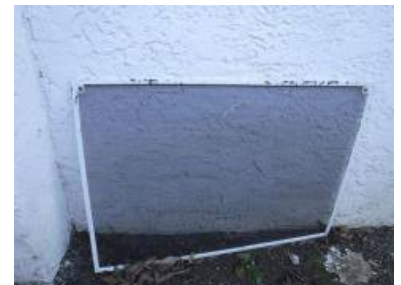
[CR] Some window(s) were difficult to open/close, especially the vertical windows. We recommend correcting the condition(s) noted.

[CR] Some window screen(s) had damaged mesh/frames/latches or were missing. We recommend correcting the condition(s) noted.

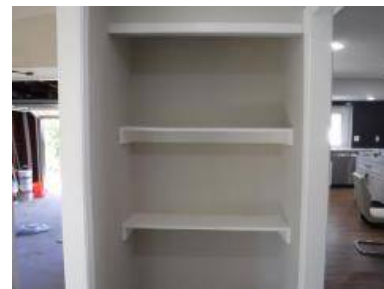
[CR] The closet door(s) were removed at a hallway area. We recommend inquiring about the condition(s) noted.

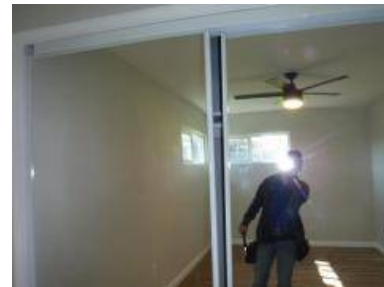
[CR] One bedroom closet doors were not the correct size. We recommend correcting the condition(s) noted.

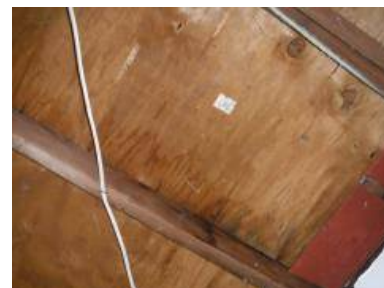
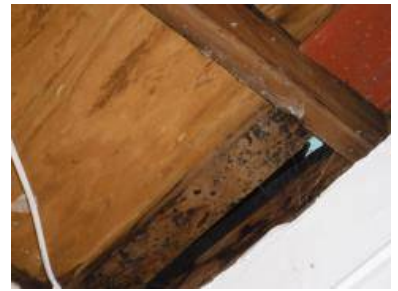
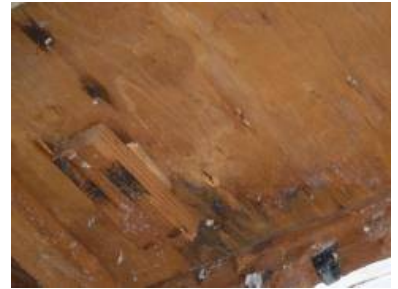
1510 VENTILATION:	The vents appeared to be in serviceable condition.
1512 WINDOWS:	The accessible window(s) were serviceable with signs of aging and wear.
1513 FRAMING:	[CR] Moisture stains were noted on the sheathing and framing in areas. The stains tested dry during the inspection. We recommend locating and correcting the source as well as any damaged materials.

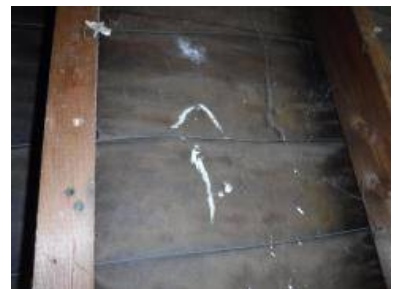
[FE] There were pest company markings present in areas. We recommend further evaluation and corrections by a specialist in the appropriate trade.

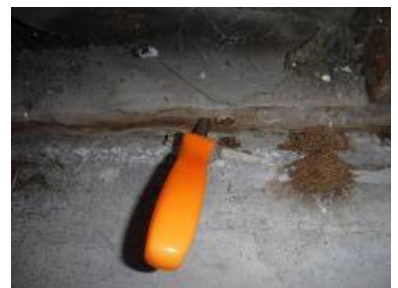
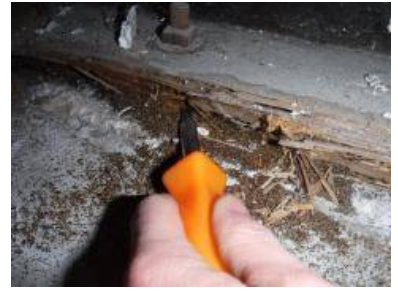
[FE] Damaged framing members were noted in several areas. We recommend further evaluation and corrections by a specialist in the appropriate trade.

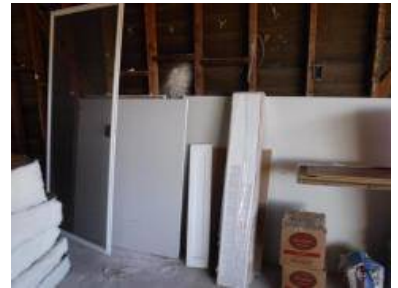
[FE] Portions of the interior walls and ceiling were not visible at this time due to stored personal items. We recommend checking these areas after the items have been removed.

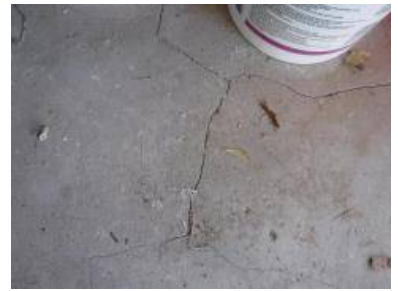
[CR] Concrete was stained in areas. We recommend correcting the condition(s) noted.

[FE] The floor was not fully visible, due to stored items. We recommend checking these areas after the stored items are removed.

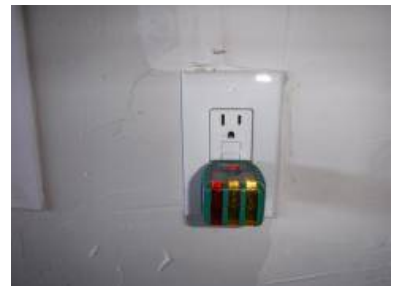
[CR] There was no power at the GFCI receptacle and it would not reset. We recommend correcting the condition(s) noted.
